# Static and Fatigue Behaviour of Impact Damaged Thick-Walled Composites

**NLR-TP-2013-511** - April 2014

R.J.C. Creemers and M.J. Smeets<sup>1</sup>

## ABSTRACT

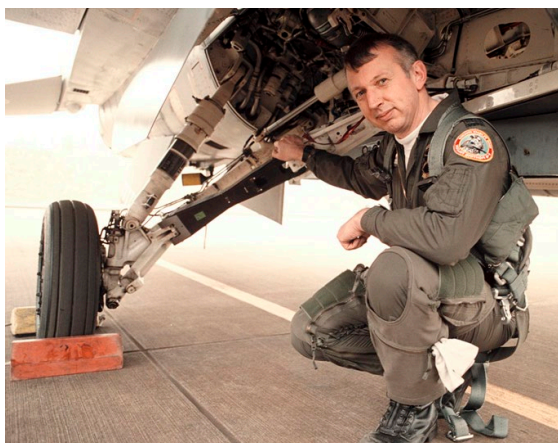
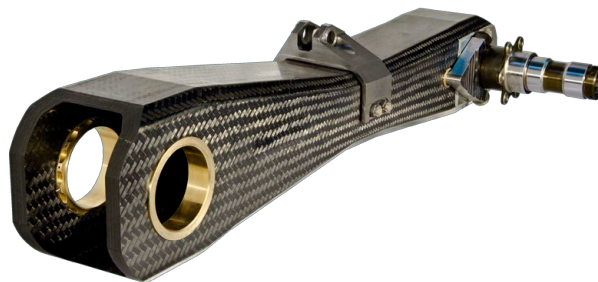
**Figure 1: Examples of composite landing gear components.**  
Left: F-16 drag brace. Right: NH90 trailing arm.

Using the Resin Transfer Moulding (RTM) manufacturing technique, it has become possible to produce thick composite components in a cost-effective way. This enables the replacement of complex metal forgings, such as landing gear components, by composite components. For more than 10 years the National Aerospace Laboratory (NLR) and Fokker Landing Gear (FLG) are cooperating in technology development for application of thick-walled composites in landing gear components. These landing gear components are typically in a laminate thickness range of 20 to 50 mm (Figure 1). They are subject to damage tolerance criteria, and a large variety of impact threats can be distinguished, both with low and high velocity, e.g. tool drop, collision with ground vehicles, hail, runways debris or tyre debris.
